U. S. NAVAL AIR ENGINEERING CENTER

GROUND SUPPORT EQUIPMENT DEPARTMENT
NAEC-GSED-106 SEPT 1976
CODE IDENT. NO. 28638

CONTROL OF CORROSION
IN
GROUND SUPPORT EQUIPMENT

INTERIM REPORT

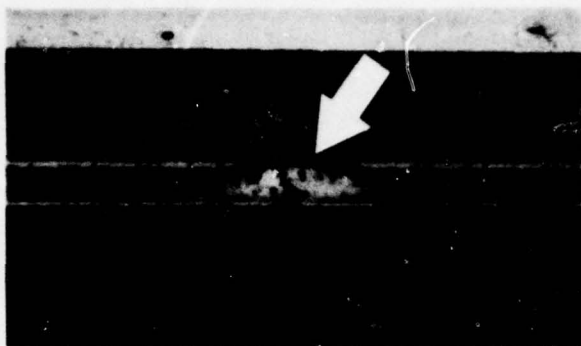
5.5.17.6. Exfoliation is a form of intergranular corrosion. It manifests itself by lifting up the surface grains of a metal by the force of expanding corrosion products occurring at the grain boundaries just below the surface. It is visible evidence of intergranular corrosion and is most often seen on extruded sections where grain thickness is less than in rolled forms. Intergranular corrosion is an attack on the grain boundaries of a metal or alloy. A highly magnified cross section of any commercial alloy will show its granular structure. This structure consists of quantities of individual grains, and each of these tiny grains has a clearly defined boundary which chemically differs from the metal within the grain center. Frequently the grain boundaries are anodic to the main body of the grain, and when the grain boundaries are in this condition and in contact with an electrolyte, a rapid selective corrosion of the grain boundaries occurs. An example of intergranular or grain boundary corrosion is that which occurs when aluminum alloys are in contact with steel in the presence of an electrolyte. The aluminum alloy grain boundaries are anodic to both the aluminum alloy grain and the steel. Intergranular corrosion of the aluminum alloy occurs. An example of exfoliation as experienced on GSE is shown in Figure 5-6 picturing the rail of a T-58 Engine Transport Trailer at AIMD, North Island, San Diego. Evidence of pitting may also be seen in this figure. Figure 5-7 shows extensive exfoliation of structural members from an E2A Aircraft Lifting Sling from the NARF, North Island, San Diego, which had to be "surveyed" because of corrosion. This is the first item of GSE encountered on Both East and West Coast NAS/MCAS

Figure 5-6. T-58 Engine Transport Trailer Exfoliation

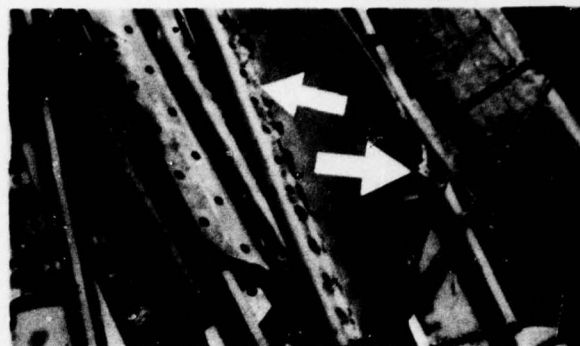
Figure 5-7. E2A Aircraft Lifting Sling Exfoliation

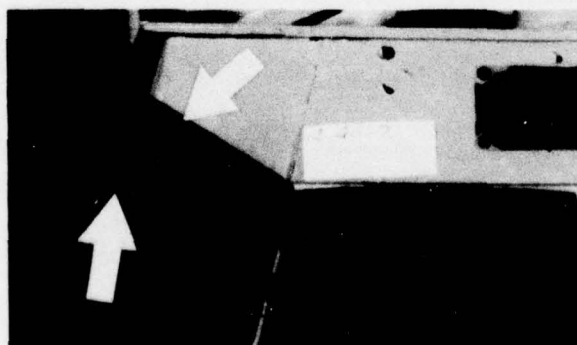
Figure 5-9. Typical Delamination - Advanced Corrosive State - Identified by Key No. 1

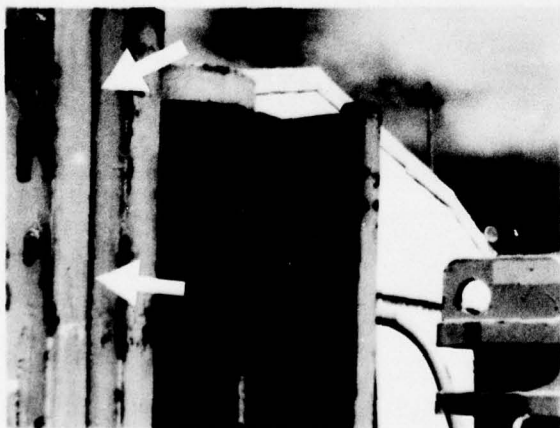
Figure 5-14. Water Entrapment
Capillary Between
Mating Surfaces.

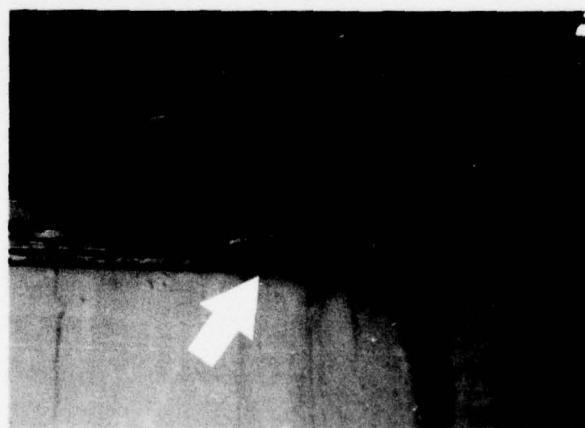
Piano type hinges on closure doors of GSE are often found to be a source of corrosion by capillary induced water entrapment, sometimes in the hinge itself if infrequently used, but generally under the bolted or spot welded flanges. Figure 5-16 shows the effect of water entrapment in the hinge of an access door on a GAED Mobile Motor Generator, MMG-2, Inet Sprague at Pensacola, Florida. The darkened paint area of the hinge and some of the finish of the door indicates that temporary corrosion prevention measures have been taken by coating with corrosion preventive compound MIL-C-16173 or MIL-C-81309. All of the examples shown in Figures 5-14, 5-15 and 5-16 are this type of water entrapment (key no. 4).

Figure 5-15. Water Entrapment
Induced Corrosion.

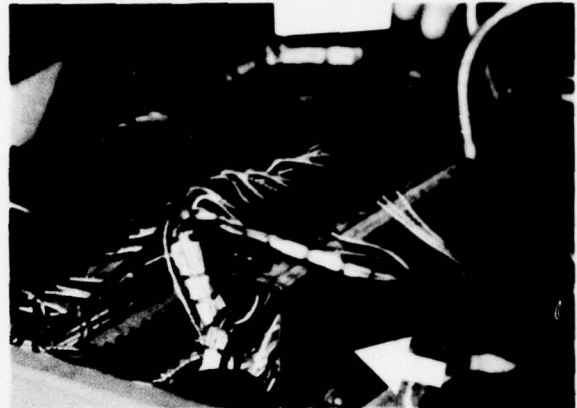
Figure 5-23. Electrical Compartment Corrosion of Terminal Strap Support Bracket

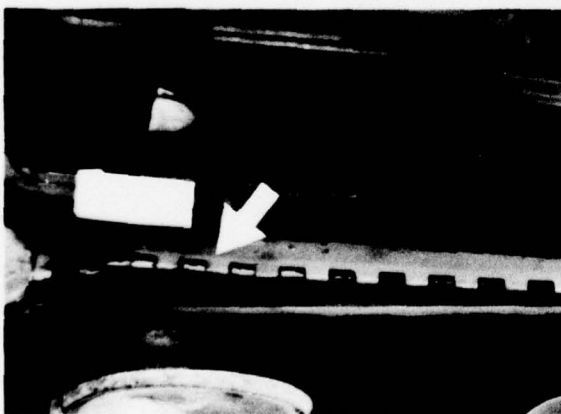
Figure 5-26. SATS Weapons Loader - Bent Hinge on Engine Compartment Cover

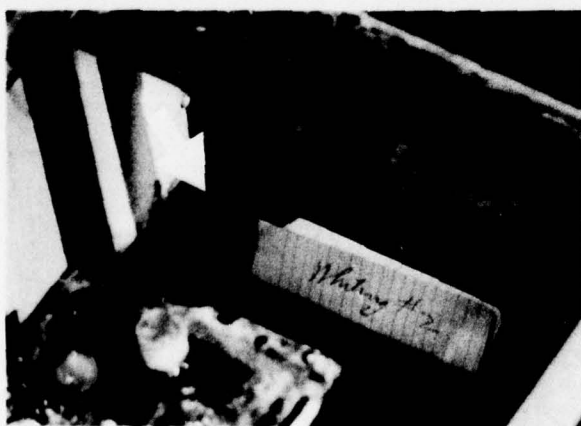
5.6.2.11. Acid attack is another category of corrosion frequently encountered in GSE. The sides and bottom of battery compartments are usually coated, however, adjacent access doors are generally heavily attacked by the acid fumes, see Figure 28. Even with acid resistant coatings and plastic battery boxes tie down devices are frequently heavily attacked as well as battery compartment access doors, see Figures 5-32, 5-33, and 5-34.

Figure 5-32. Tow Tractor Battery Com-
partment - Acid Induced
Corrosion

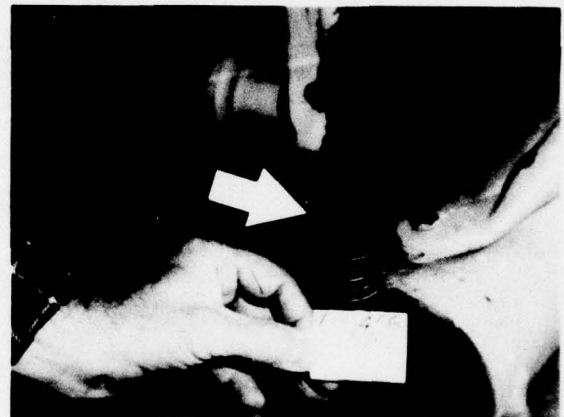
Figure 5-37. AERO 51-B Munitions
Handling Trailer - Exposed
Screw Unprotected

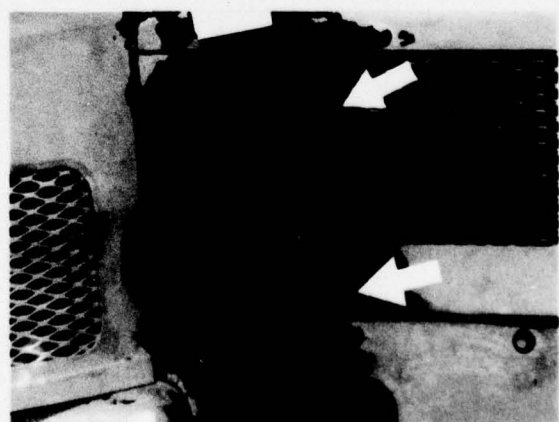
Figure 5-39. SATS Weapons Loader -
Corrosion from Muffler

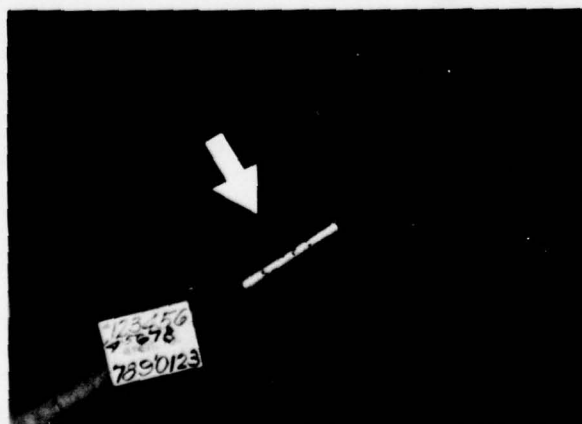
5.6.2.17. Pitting of piston rods was much in evidence on GSE which remained for extended periods in "open skies" storage in near ocean atmosphere. An example is of the lift cylinder piston rod of an Aero 33D Bomb Truck in the storage yard at Key West, Figure 5-44. Many aircraft jacks from the full environmental range of their use were found to be similarly attacked by pitting corrosion. Hand rails of maintenance stands, tow bar handles, arm rests, in fact most areas where acid from hand contact exists on GSE show considerable pitting. The arm rest on a TA-75 Aircraft Tow Tractor, Figure 5-45, is typical of many such instances of pitting corrosion, (Key No. 17).

Figure 5-44. Aero 33-D Bomb Truck - Pitting Corrosion on Piston Rod

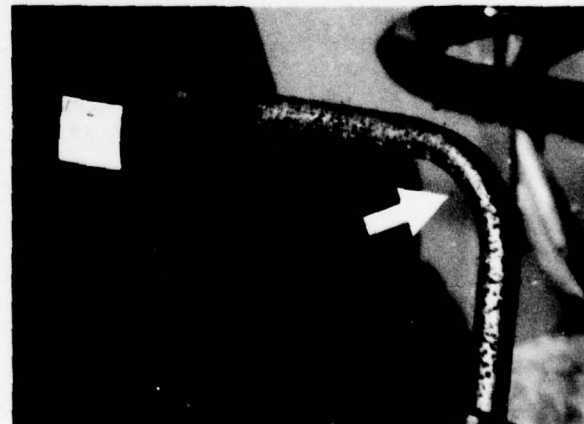
Figure 5-45. TA-75 Aircraft Tow Tractor - Pitted Arm Rest
